46TH TURBOMACHINERY & 33RD PUMP SYMPOSIA
HOUSTON, TEXAS | DECEMBER 11-14, 2017
GEORGE R. BROWN CONVENTION CENTER

Gas turbine with rotor crack vibration diagnostics

Machine train: Gas Turbine - Generator

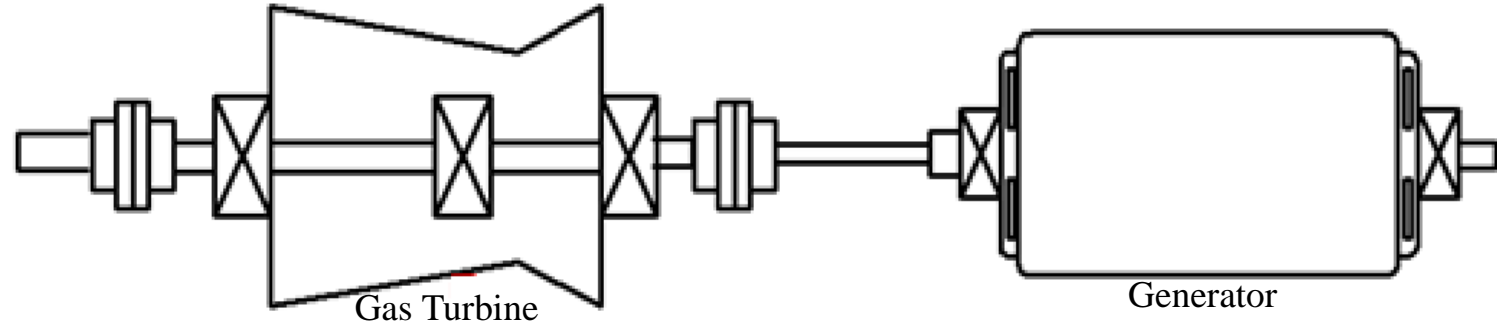
The machine train consists of a single-shaft heavy duty Gas Turbine (120MW, 3000rpm, in service since 1998) directly rigidly coupled on hot end to a synchronous generator. The compressor portion of the gas turbine rotor consists of stacked blade wheels held with tiebolts and it is connected to the turbine rotor via marriage joint. The turbine rotor consists of three turbine wheels with buckets held together with through bolts. The rotor is supported by three main journal bearings (BrG.1,2 Elliptical, BrG.3 tilting pad).
